DATE: January 26, 2018
TO: Flat Creek Water Improvement District
CC: Robert Ettema, PhD, PE
FROM: Edward Kempema, PhD
1731 Mill Street
Laramie, WY 82072
307-399-7921
kempema@uwyo.edu

SUBJECT: REPORT ON SITE VISIT TO FLAT CREEK, JACKSON, WY

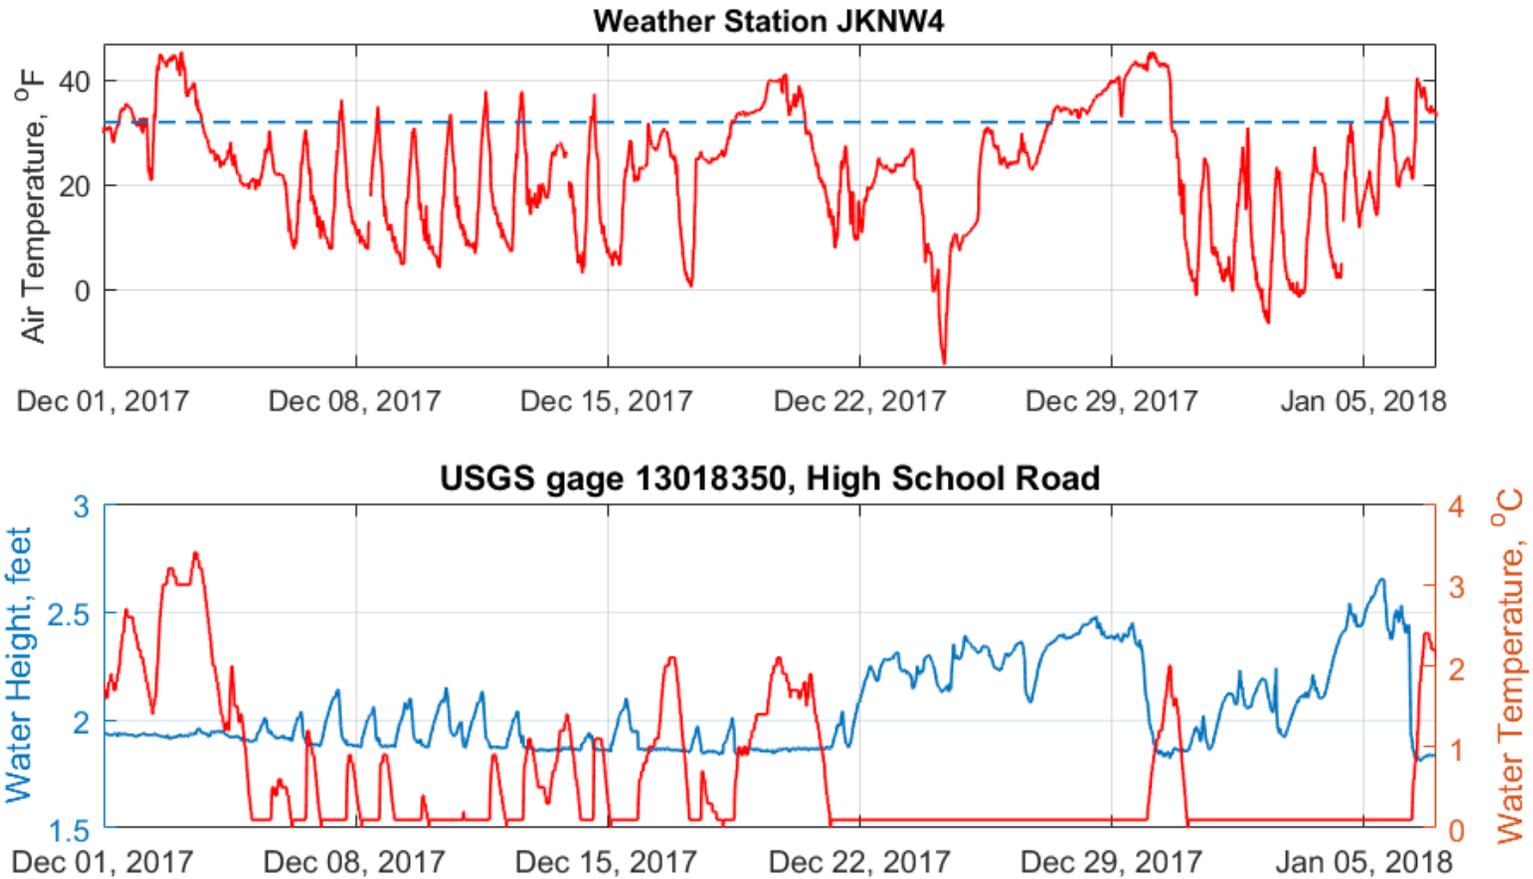
Figure 1. TOP: Air temperatures from weather station JKNW4 from the period of December 1, 2017 through January 5, 2018. The dotted blue horizontal line is at 32°F. BOTTOM: Water level and temperature measured at USGS gaging station 13018350, located just above the High School Road Bridge. There is an inverse relationship between water level and water temperature at this site. When water temperature drops to zero, water level rises in response to ice formation. Above freezing water temperatures result in a drop in water level, presumably due to melting and/or release of all upstream ice. Note that air temperature is in °F while water temperature is in °C..

Daily air temperature records from weather station JKNW4, along with water level and temperature records from the USGS gaging station upstream of the High School Road Bridge (USGS gage number 13018350) are shown in Figure 1. The period from December 1, 2017 through January 5, 2018 can be broken into two phases. From December 1 through 21, daytime high temperatures cluster around the freezing point, and night-time lows range into the single digits (°F). As a result, water temperatures cooled to the freezing point at night, and rose to above 33°F (0.5°C) during the day. These diurnal water temperature variations are matched by inversely-correlated water level changes; i.e., when water temperature was at the freezing point, the water level rose by up to 0.2 feet, but when the temperature rose, water level dropped. This trend was characterized by the occurrence of open water with supercooling and anchor ice generation along the creek at night, followed by anchor ice melting or release during the day. On December 21, a cold front passed through the area, with air temperatures reaching a minimum of -14°F on December 24. This cold front generated widespread anchor ice formation along the entire creek bed that stayed in place until the evening of December 29 (Brian Remlinger, personal communication), even though air temperature rose above the freezing point by early morning on December 27 (Figure 1).

Water level dropped precipitously at about 6:30 PM on the 29th, followed by rising water temperatures at about 11:30 PM (Figure 1). By the next day, essentially all anchor ice and border ice had been flushed out of the Creek along AE's designated walking routes (Brian Remlinger, personal communication). At this time, we only have levels and temperatures from the USGS gage for late December and early January. However, AE downloaded the 6 Hobo pressure loggers that are deployed along the Creek on December 13. Comparison of the USGS gage record with the Hobo data from December 1 through 13 show similar temperature and water level trends, strongly suggesting that the source of the warm water arriving at High School Road was from upstream of north Cache Street, approximately 3.7 miles (6 km) upstream of the gaging station.

1. **Manage the creek's thermal condition.** The likely feasible way to do this via the judicious use of the existing thaw-wells. The purpose here is to produce the situation Figure 1 shows for the period of December 1 through 22, whereby thaw-well use promoted the daily release of anchor-ice at key locations along the creek. My observations indicate that small amounts of released anchor ice can be flushed through the creek without jamming. Note that complete elimination of anchor ice is infeasible.

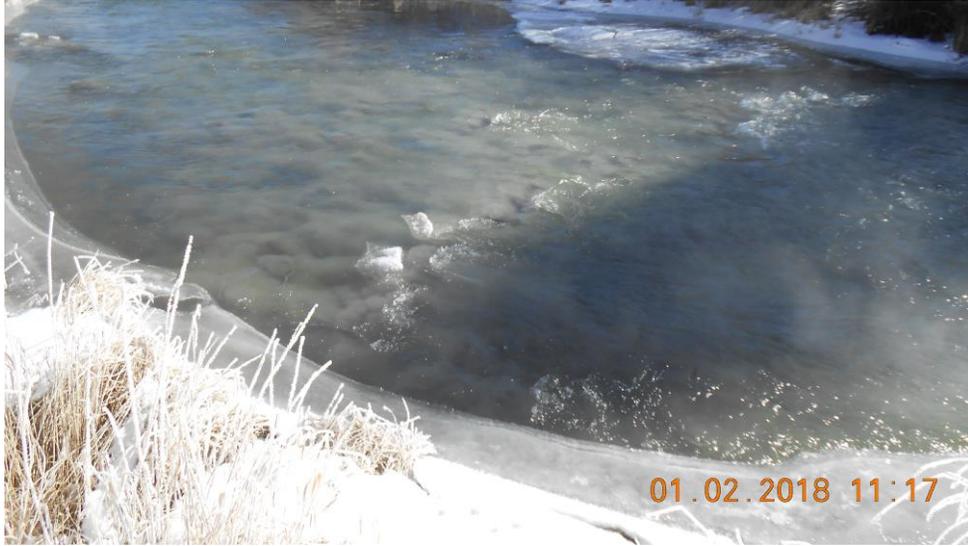
Figure 2. Typical anchor ice coverage on the bed of Flat Creek on the morning of January 2, 2018. Essentially all of the bed observed bed was covered with a 4" to 8" (10-20 cm) thick layer of anchor ice. The emergent ice masses visible in the left center of the figure indicate that this anchor ice mass has grown by accretion of anchor ice drifting down from upstream in addition to in situ growth.

"The 3.5 miles of Flat Creek flowing through the Town of Jackson can generally be characterized as wide, shallow, single threaded, moderately meandering, low gradient and stable (Figure 2). Channel width ranges from about 25 up to 75 feet, with over 75 percent of the wetted surface area comprised of water depths of less than 1.0 feet. Sinuosity (ratio of channel length to valley length) varies from about 1.4 in the Karns Meadow section down to 1.0 (straight) in several sections that have been channelized and confined by urban development. Few islands and bars are present and the channel gradient is 0.6 percent. The channel itself is exceptionally stable, characterized by well-vegetated stream banks and a paved substrate of small to large cobble." (Wesche and Wesche, 2003)

- Flat Creek went from ice-free conditions on December 30 (Brian Remlinger, personal communication) to a completely anchor-ice carpeted creek bed on January 1 and 2. This anchor-ice carpet was observed on the lower section of the designated walking route, from High School Road to the pedestrian bridge upstream of Garaman Park, on the evening of January 1. On January 2, the entire designated walking route was traversed; essentially all of the visible creek bed was carpeted in anchor ice (Figure 2). Significant anchor-ice free portions of the bed were observed on the left side of the Creek below the Kelly Tube (~600 square feet, these are very rough estimates), on the right side of the Creek below Virginia Lane (~400 square feet), and in the channel above the 2nd pedestrian bridge upstream of High School Road (~2500 square feet). This last location had a complete anchor ice cover in the morning that had released by the time we returned at 2:15 PM (Figure 3).

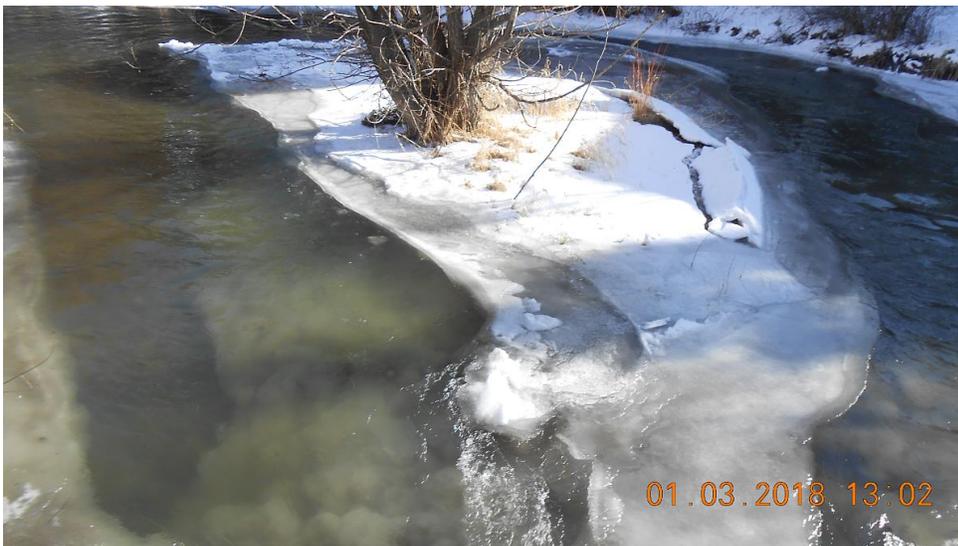
Figure 3. On January 1 and the morning of January 2, the entire bed in this region was carpeted in anchor ice. On the afternoon of January 2, the anchor ice on the left side of the image had released from the bed (dark area) and drifted downstream as slush ice. By the afternoon of January 4, this entire cross section was anchor-ice free. View looking upstream from 2nd pedestrian upstream of High School Road.

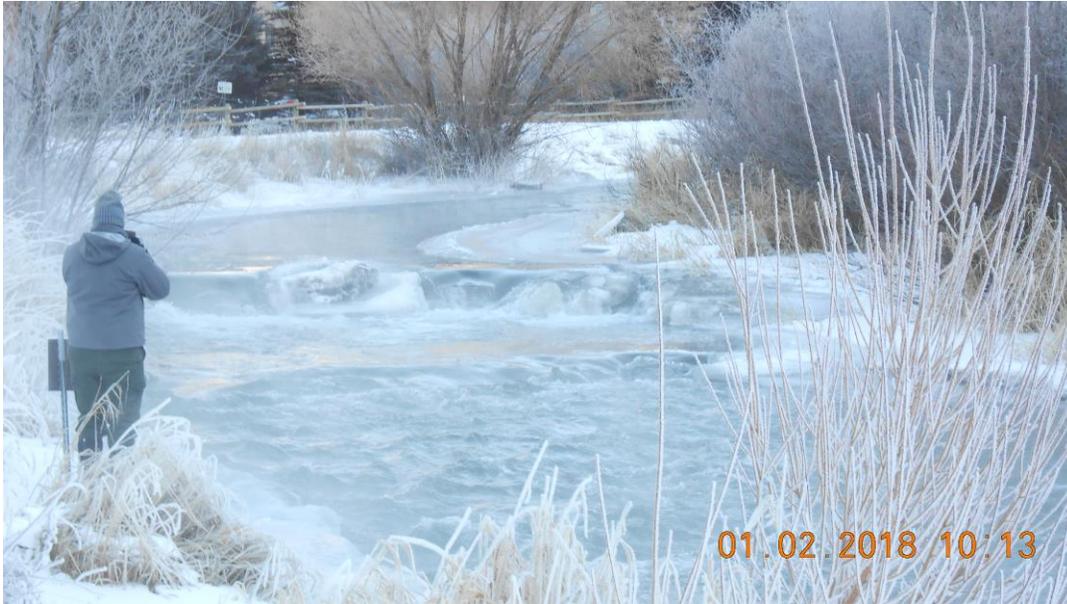
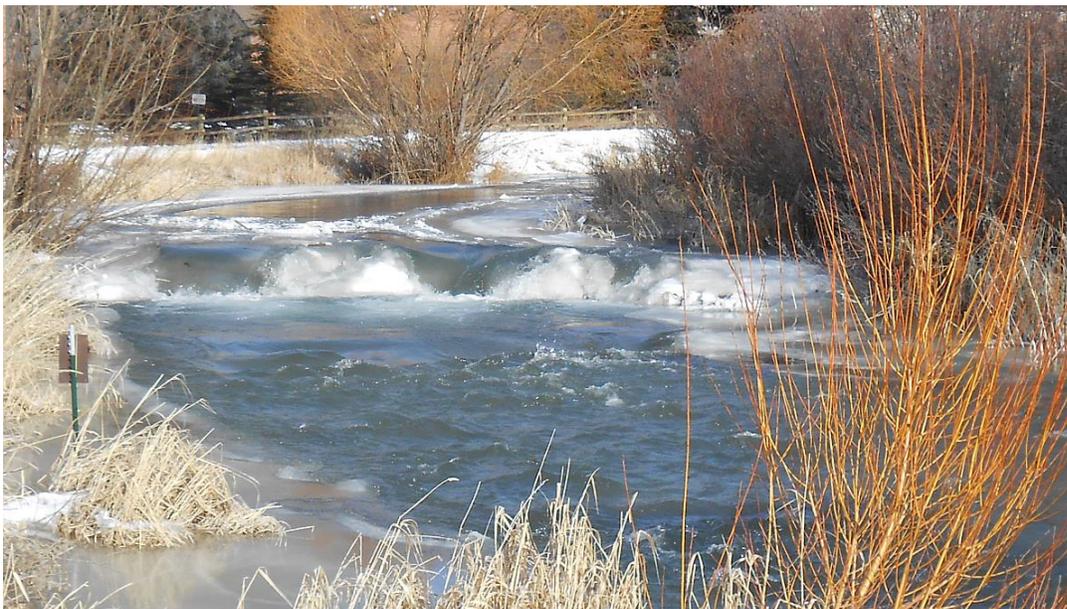
- Although anchor ice was ubiquitous, it did not have a uniform thickness along the Creek. All of the observed rock over pour structures and rock weirs along the designated walking routes had associated anchor ice weirs that raised upstream water levels (Figure 4). Due to safety concerns, I was not able to directly measure the ice thicknesses of any of these weirs. There is a fundamental difference between an anchor ice weir and an anchor ice dam. Weirs are composed of accumulated frazil and slush ice, and are completely under the water surface. In contrast, anchor-ice dams form when ice weirs breach the air/water interface. Anchor-ice dams

Figure 4. Changes in an anchor ice weir between January 2 at 10:13 AM (TOP) and January 4 at 11:56 AM (BOTTOM). This anchor-ice weir has grown and become partially emergent in 50 hours, and is beginning to transition from an anchor-ice weir to an anchor-ice dam. Water levels have increased both upstream and downstream of the dam, as seen by the flooded rocks in the center of the image above the ice-covered rock over pour structure, and the flooded grass in the lower left of the image below the rock over pour. There is very little change in the amount of border ice cover growth during this period. The T-stake on the left contains a time-lapse camera.

2. To the extent possible, **remove or modify locations (often creek-improvement structures) where anchor-ice weirs dams commonly occur**, so that such ice dams occur much less frequently (or not at all). This part of the approach requires that FCWID identify the locations where anchor-ice dams commonly occur.

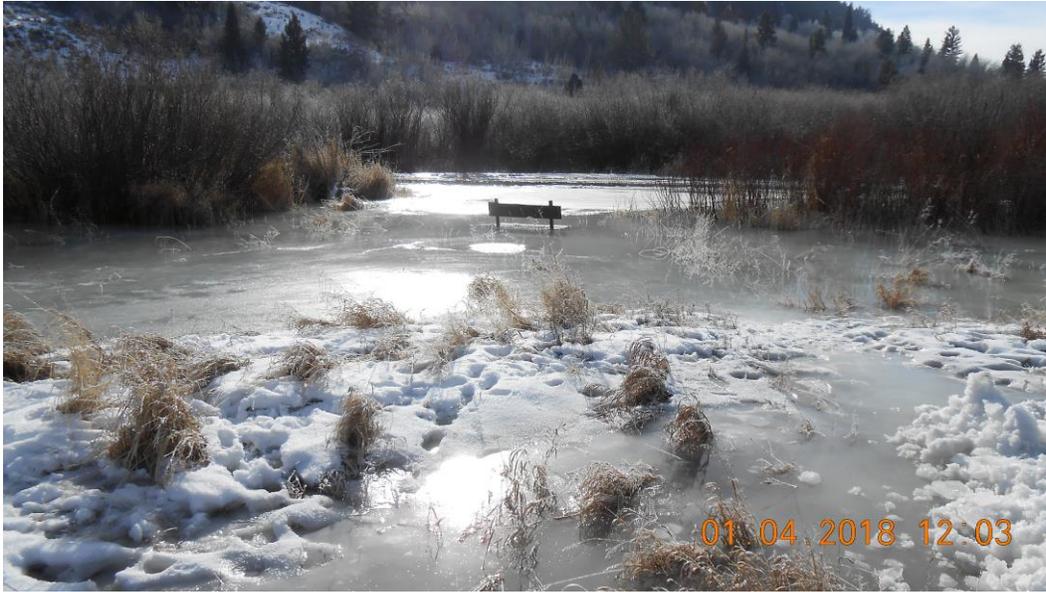
- A second area of significant overbank flooding occurred along the JH Community Pathway around 100 to 120 yards downstream of the Pathway intersection with Elk Run Lane. Icings associated with this over bank flooding increased about 8" in thickness between January 2 and January 4 (Figure 5). This location provided a good illustration of how overbank icings form. These icings form as thin sheets of water freeze as they flow over existing ice layers, creating a very dense, grounded ice mass. Unlike anchor ice attached to the stream bed, these ice masses resist melting during warm-weather periods, filling space that might otherwise accommodate subsequent overbank flooding.

Figure 5. Significant overbank flooding along the JH Community Pathway downstream of Elk Run Lane. The park bench seat is estimated to be about 16" high, water level rose 6" to 8" between January 2 and 4 due to an anchor ice weir that formed on an existing rock over pour structure to the left of the photograph.

An alternative or additional action (where feasible) could be to construct relatively low levees around certain dwellings, protecting them from flooding.

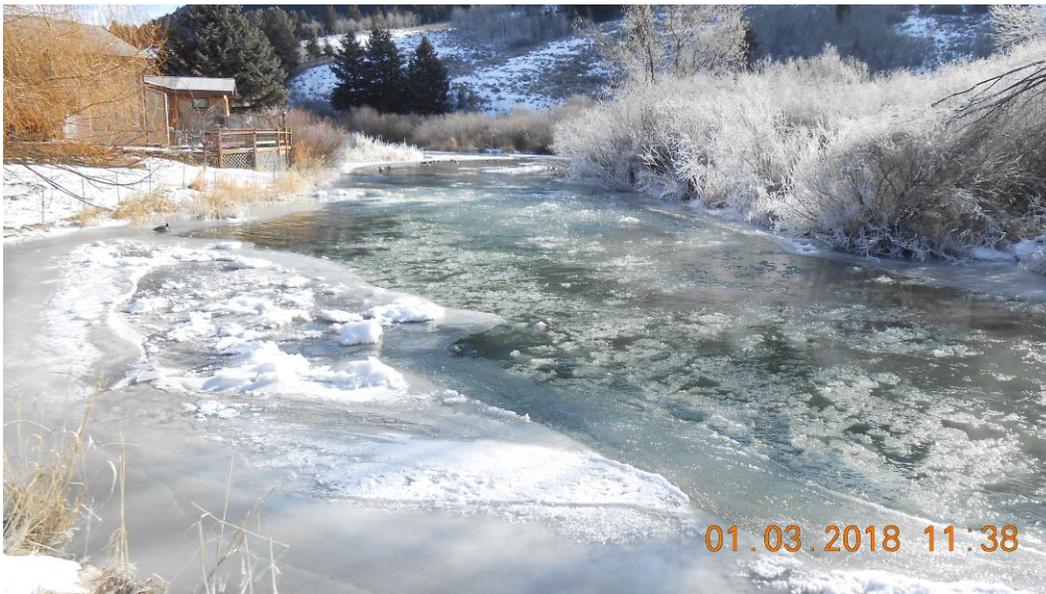
- Anchor ice was released from some of the bed starting on the afternoon of January 2. Large masses of anchor ice, covering several square yards to several 10's of square yards would rise from bed (Figure 6). It is not clear why anchor ice released from some portions of the bed, but not others. As this anchor ice drifted downstream, it would become disaggregated by flow turbulence, breaking up into smaller and smaller flocs until completely disaggregated. It appeared that the majority of the released, drifting anchor ice passed over existing anchor ice weirs, although a recently-released, relatively dense anchor ice mass did choke the channel upstream of the Garaman Park diversion structure for 150 or 200 feet, and contributed to local overbank flooding (Figure 7). Surprisingly, once this mass choked the stream, the majority of subsequent anchor ice arriving from upstream appeared to pass under the mass and over the anchor ice weir. Relatively little slush ice grew upstream once the initial mass was emplaced.

Figure 6. Released anchor ice drifting downstream (right side of image) and accumulating in low-velocity zones (left side of image). The relatively large mass of drifting ice is recently-released anchor ice. As it continues to drift downstream, it will become more disaggregated and dispersed across the creek surface. If cold air temperatures persist, the deposited slush ice on the left side of the image will freeze into a surface ice cover that could eventually bridge the Creek.

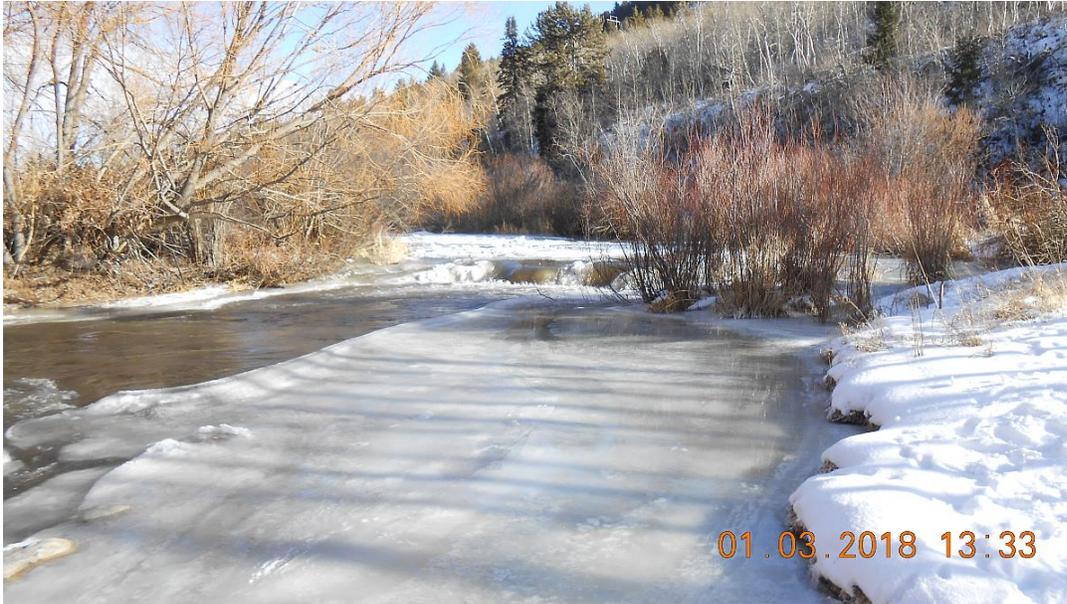
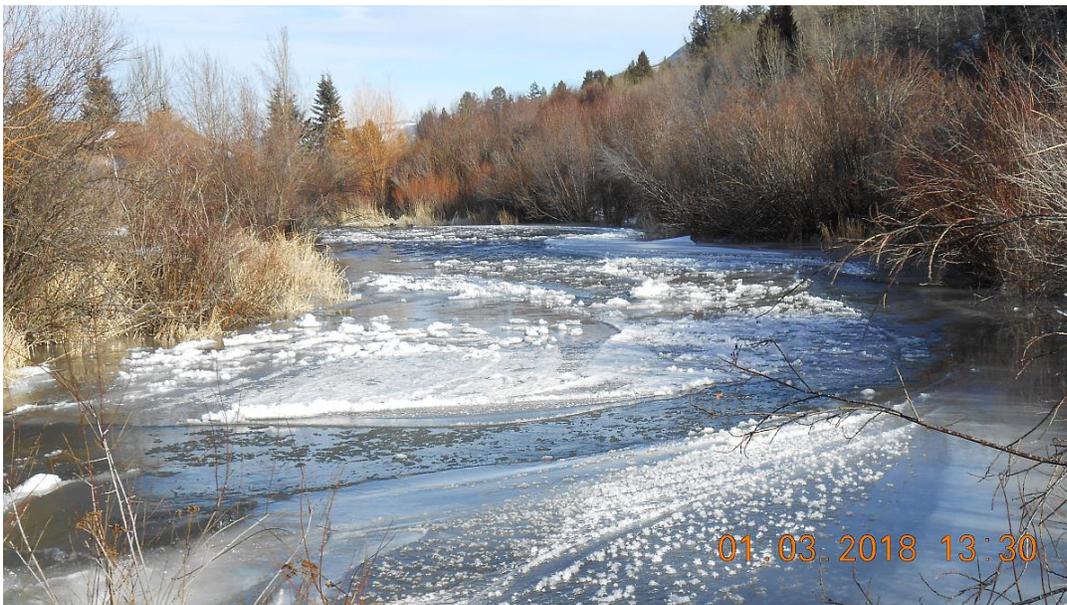
- Anchor ice weirs raise upstream water levels, which may lead to overbank flooding. The worst flooding observed during the site visit occurred around an anchor-ice weir that developed on a rock weir for the diversion in Garaman Park. This anchor-ice weir grew over a period of six days, from December 31 through January 5. By January 5, overbank water levels were threatening infrastructure and a track hoe was hired to remove the anchor-ice weir. The track hoe was not able to reach the weir, but did clear accumulated slush ice from upstream. The next day the dam was thermally eroded, which mitigated the flooding threat (Bill Wotkyns, personal communication).

Figure 7. TOP: An anchor-ice weir (transitioning into an anchor-ice dam) on an existing rock weir diversion in Garaman Park. BOTTOM: A juxtaposed surface ice accumulation, consisting of released anchor ice, located upstream of the anchor ice dam shown in the top image. The approximately 150-foot long ice accumulation chocked the channel over a 5-minute period on January 2.

Thaw-well use should involve water release at key locations where it will have greatest benefit. For example, the discharge point for Thaw Well #2 could be moved about 100 yards upstream of its present location so as to discharge warm water above the rock weir known to form an ice dam.

For example, the diversion rock weir at Garaman Park is a location where, during the last two winters, ice dams commonly occurred and caused localized flooding that threatened nearby creek-side condos.
